Tips and Techniques for Standard Transmission Diagnosis, Part 2

By Mike Weinberg
Contributing Editor

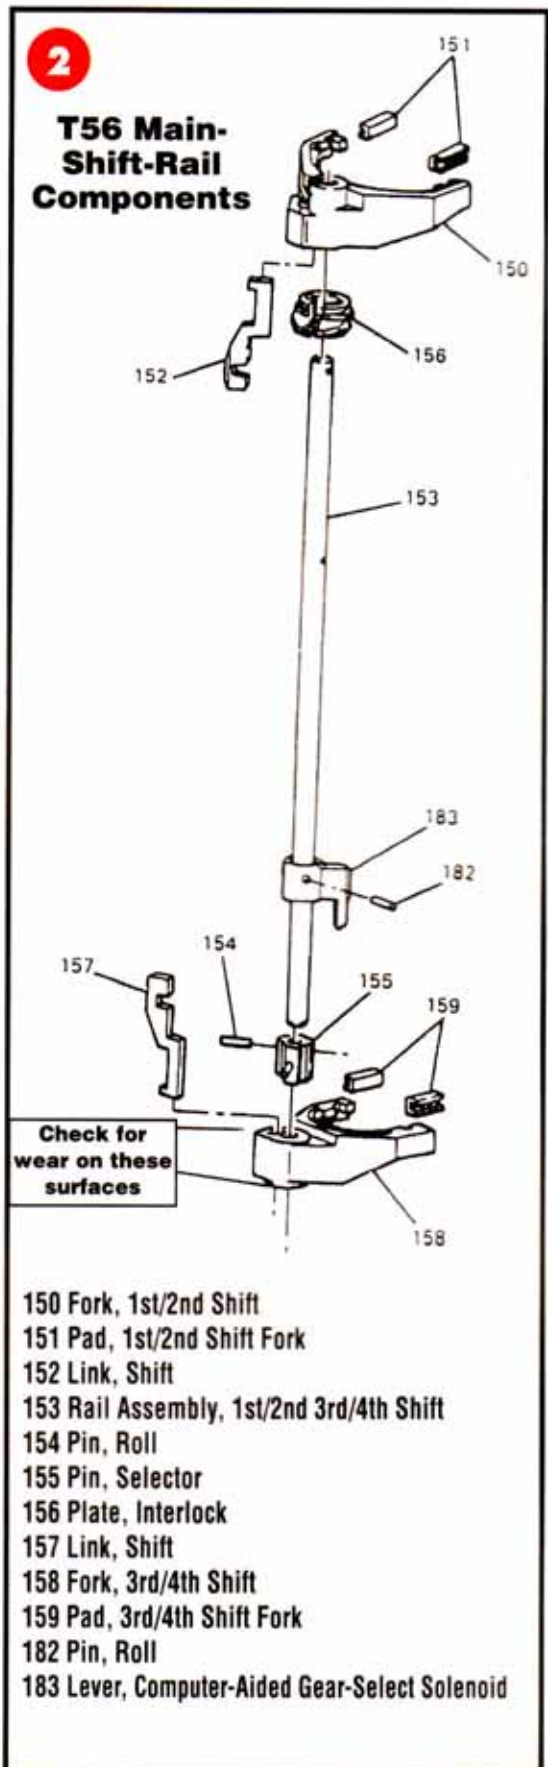
The synchronizer and gear are new, so it is easy to conclude that the damage was an effect instead of a cause. In passing, the rebuilder realizes that he inspected the shift forks but never removed them from the shift rail (see Figure 2). Now the aluminum forks and steel shift brackets are removed from the shift rail, and the rebuilder finds 0.020 inch of wear on the aluminum where the steel bracket contacts the fork. A little research with a standard-transmission tech service reveals that an updated steel fork is available, and the problem is solved.
