Understanding The 290 Transmission

**By Mike Weinberg
Contributing Editor**

HM290 (5LM60) Unit Description

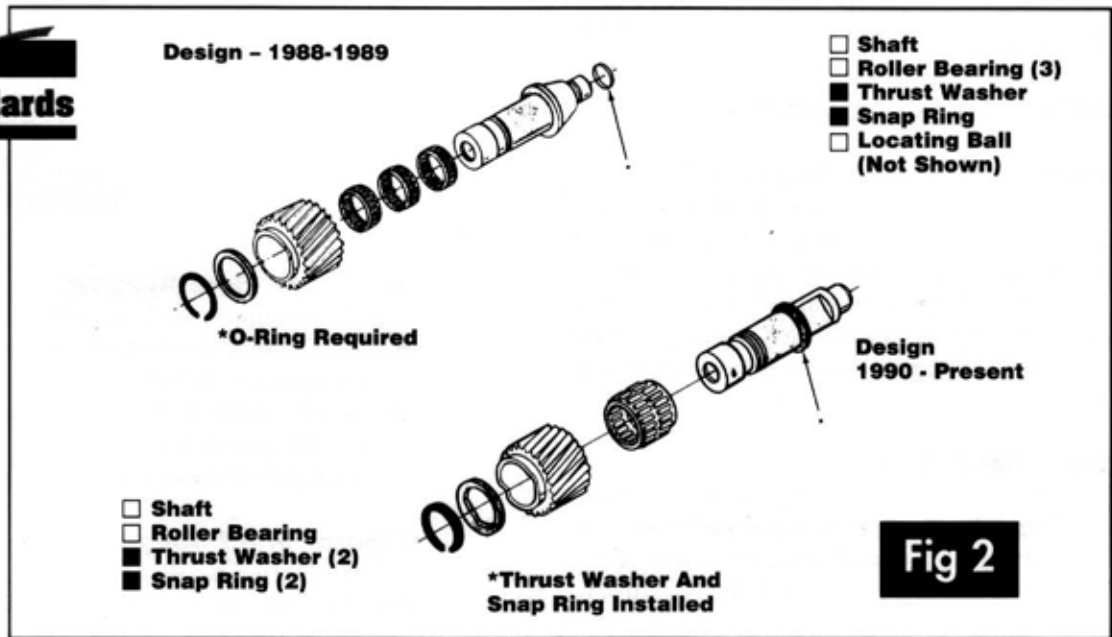
1988 and 89 models use 3 needle bearings to support the reverse idler gear, with the shaft having a shoulder, 1 thrust washer and 1 snap ring. 1990 to present design incorporates 1 double-row needle bearing supporting the idler gear, a shaft without a shoulder, 2 snap rings and 2 thrust washers (See Figure 2).

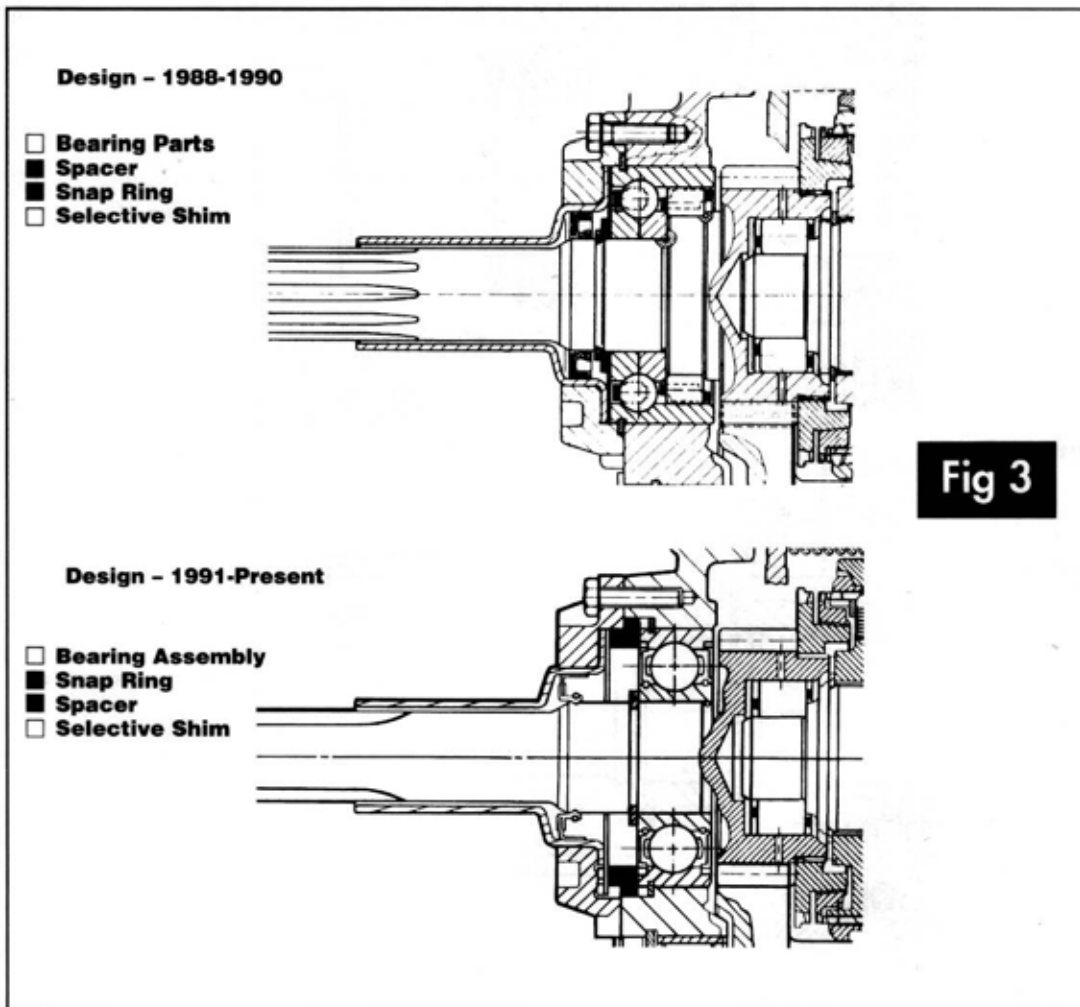
1988-89 models were built with a multipart input bearing using both rollers and balls (See Figure 3). In 1991, the design was changed to a one-piece ball bearing. Both designs use a selective shim to set end-play.

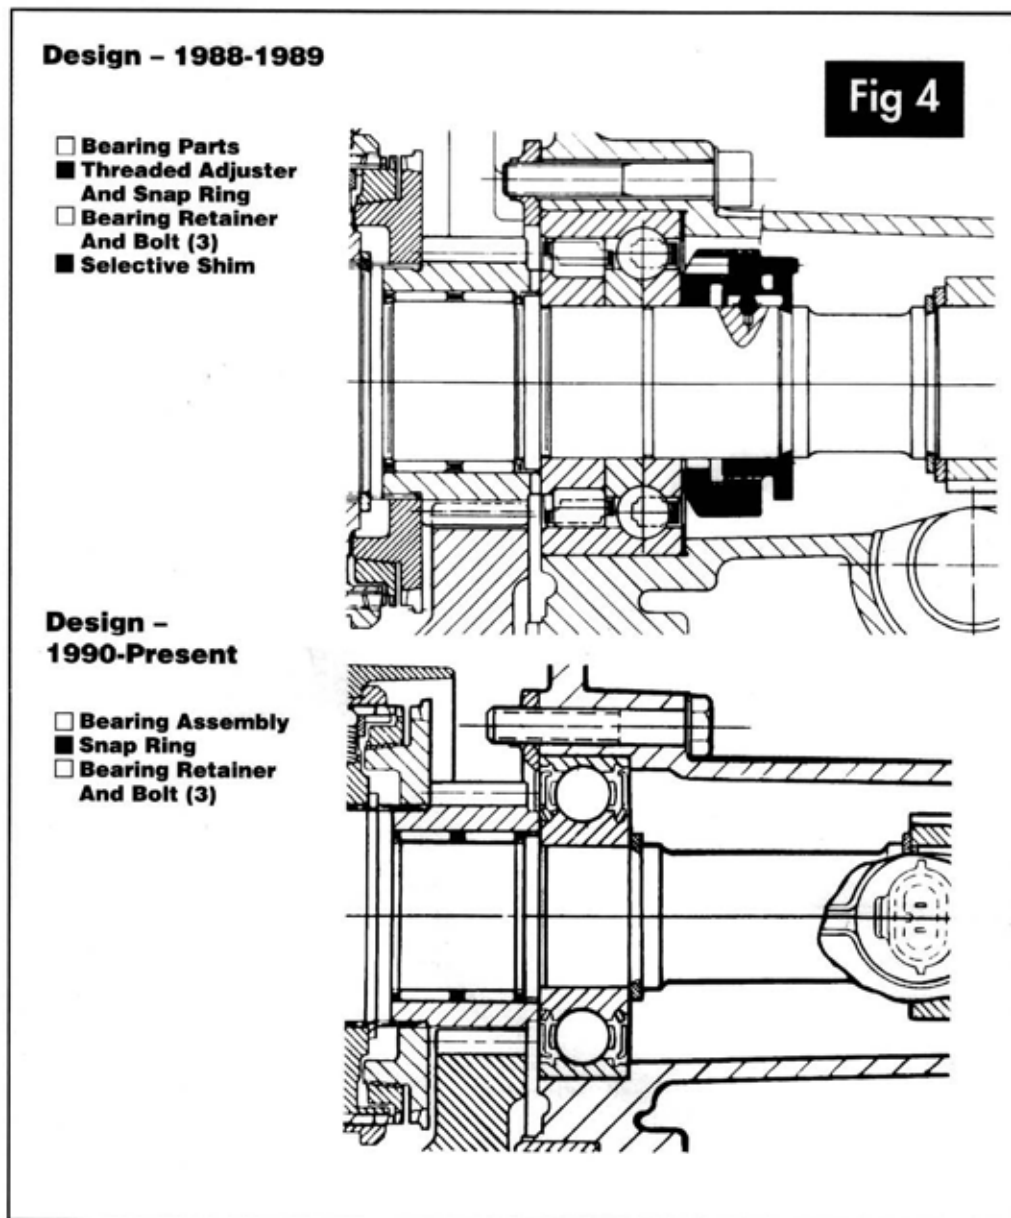
1988-89 units were built with a multipiece bearing (balls & rollers), a threaded adjuster, a selective shim and a snap ring. In 1990, the design changed using a single-row ball bearing and a snap ring. The threaded adjuster and selective shim no longer are incorporated in the design (See Figure 4).

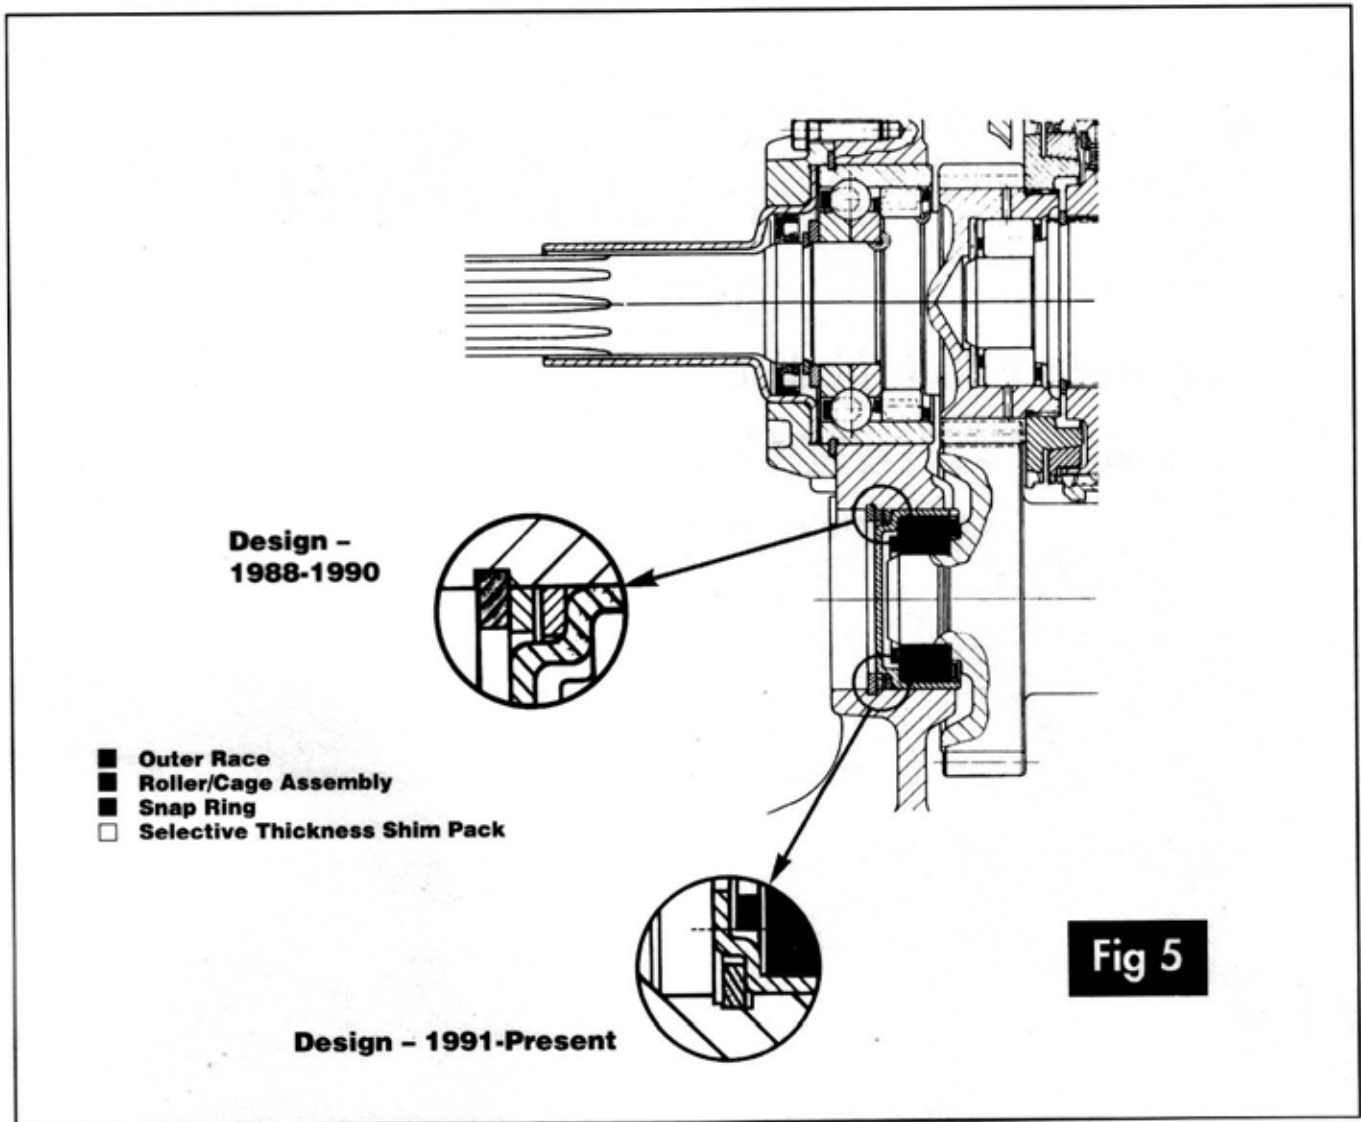
1988-89 used a roller bearing at each end with an outer race enclosed on one end and a roller set with a flexible cage. The front c/s bearing has selective shims to control counter shaft endplay. 1991 brought a design change that eliminated the selective shim at the front counter shaft bearing (See Figure 5). Endplay is set by the design and fit of the case halves and is not adjustable.

design units. There is no way to set endplay on the counter shaft. Many rebuilders have called with units with excess endplay that clunked on throttle tip in and tip out. We are working at present to find a practical way to adjust endplay on the counter shaft during a rebuild. If and when this occurs, it will be printed here. In doing the research for this article, I discussed this problem with the engineers at New Venture Gear. They have done extensive research on throttle-related clunk and their findings indicate that the problem is not transmission related. Clearly there will be transmissions that can cause a clunk because of internal damage, but with a good unit, the clunk may be outside the gear box. The improvements made in engine throttle response through the advanced fuel-injection systems now available are part of the problem. Instant throttle response taking the slack out of various driveline components may "walk through" drive shafts and sound as if it originates in the unit. Swapping brand new units with those suspected of clunking made no difference, according to the engineer in charge of the 3500 program. It may

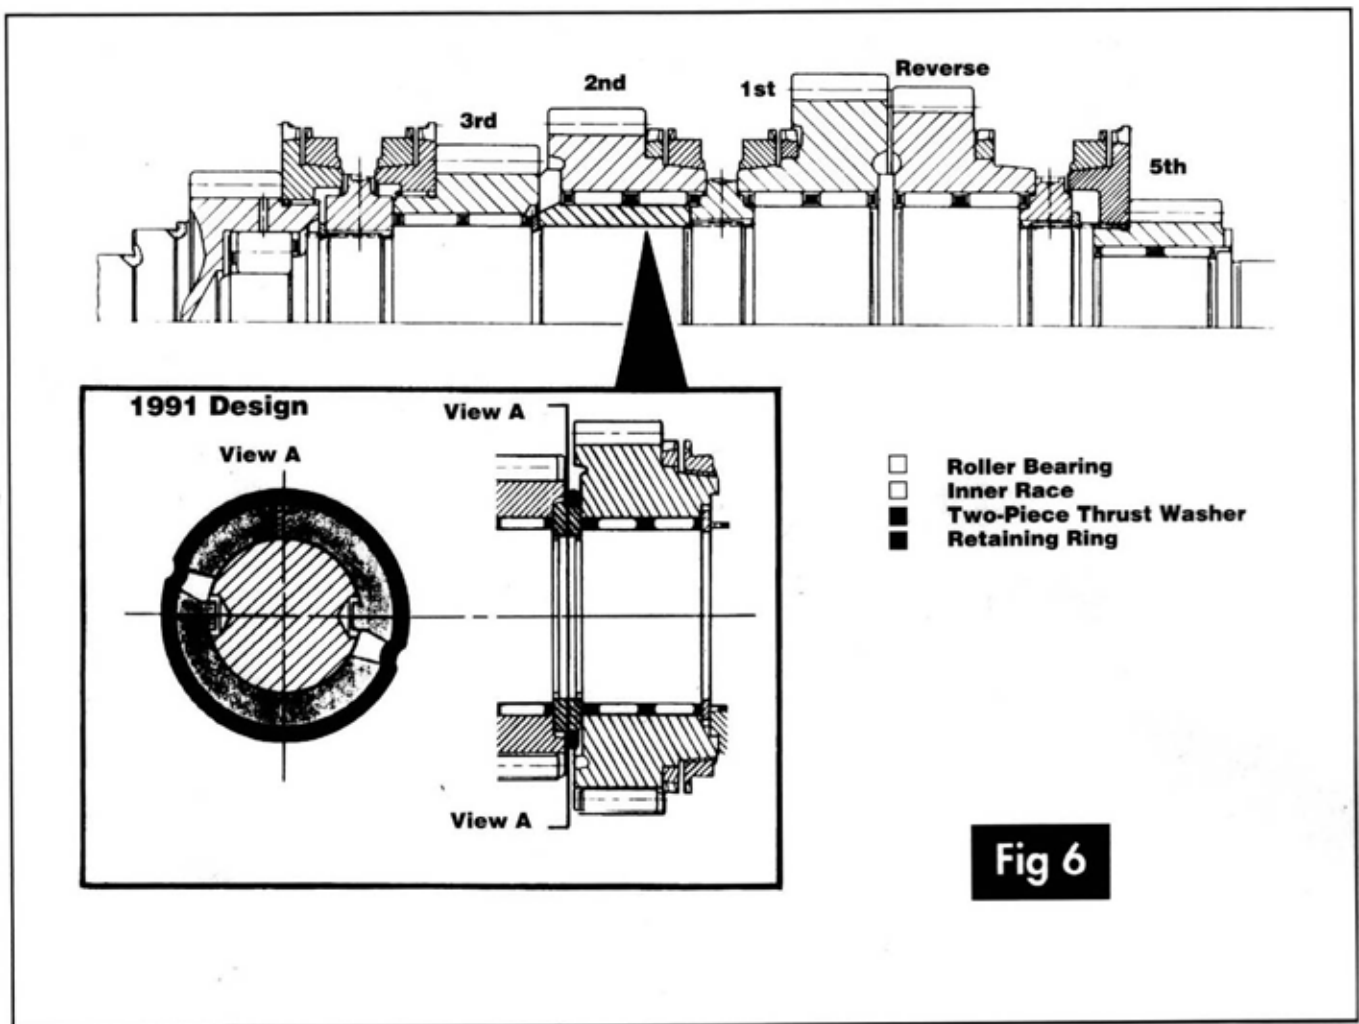
Fig 6

complete shift linkage making it into a single-rail system (See Figure 6). The unit was renamed the New Venture 3500. New Venture Gear is a joint effort between Chrysler Corp. and General Motors, producing transmissions for both firms. The NV3500 (ex-290) now is found in GM and Dodge trucks.
