Shifting America's Sports Car:

# Corvette Gearboxes

By Mike Weinberg  
Contributing Editor

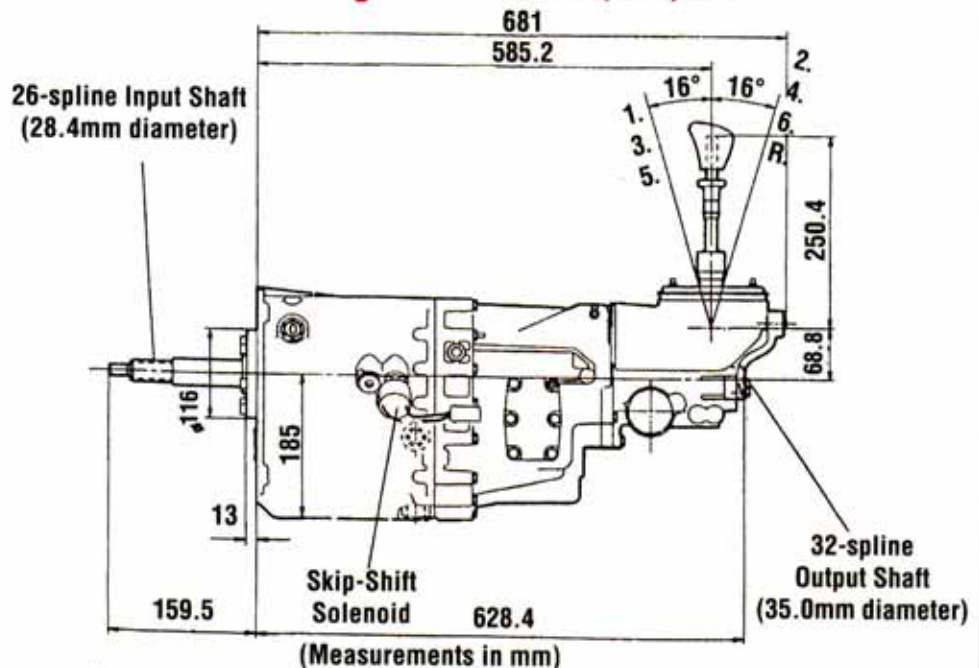
## S6-40 Transmission - Engine Model L 98/LT1/LT4

Input Torque (ft./lbs.)	1st Gear	2nd Gear	3rd Gear	4th Gear	5th Gear	6th Gear	Rev. Gear	Mass (lbs.)	Oil Capacity (L)
400	2.68	1.80	1.29	1.00	0.75	0.50	2.50	160	2.2
450	2.68	1.80	1.29	1.00	0.75	0.50	2.50	160	2.2

transmission manufacturer, the manual-transmission option now was a six-speed unit designated the S6-40. This new model was equipped with dual-cone synchronizers and provided excellent, precise shifting while being stout enough to handle the increased horsepower and torque of the 1988 model. The S6-40 option made the new model live up to its design capabilities. The difference between the new unit and the older 4+3 was as night and day.

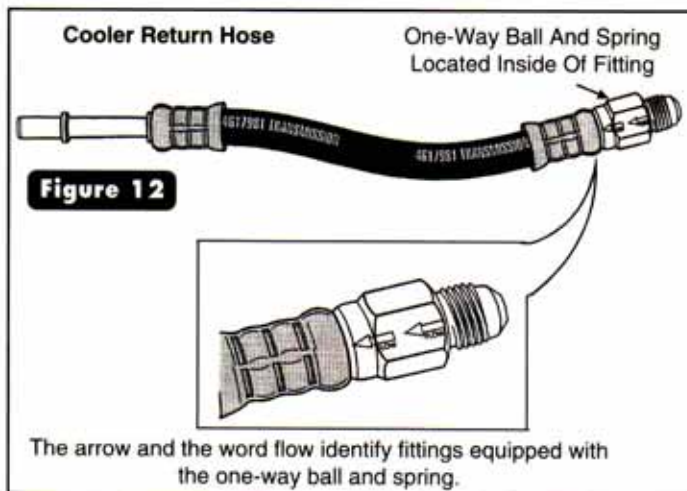
The cause may be that the one-way ball and spring in the return cooler hose (See Figure 12) may be sticking and inhibiting cooler flow to the return cooler fitting, which is the rear cooler fitting on the transmission.

Locate the return hose, which is near the radiator as shown in Figure 13. The threaded fitting will have an arrow and the word *flow* identifying the one-way ball and spring. Remove and discard the hose shown in Figure 12 and reconnect the existing lines with a suitable hose. After making the repair, ensure that there is a minimum of 1 quart of fluid flow in 20 seconds when the rear cooler line is placed into a container and the transmission selector is in Neutral.
